Knight's Marine Surveyor Inc.

Survey #: 123455 Surveyor: Jeff Knight
Survey Date: 10/23/2007
Vessel Surveyed at: 220 Sun Lane
San Diego, CA 34451
Client's Name: Jim Buyer
300 Tuna Dr.
San Diego, CA 34451
Survey For: Purchaser Survey Purpose: Assess Overall Condition

100	Vessel Type	Motor yacht.
101	Year Built	1990
102	Make / Model	Grand Harbour 57' Express Cruiser
103	Vessel Name	My Glory
104	Hull ID	HAT876768
105	State License #	CA4566
106	Home Port	San Diego
107	Tonnage	25 GRT
108	Est. Top Speed	10 knots
109	Fair Market Value	\$315,000

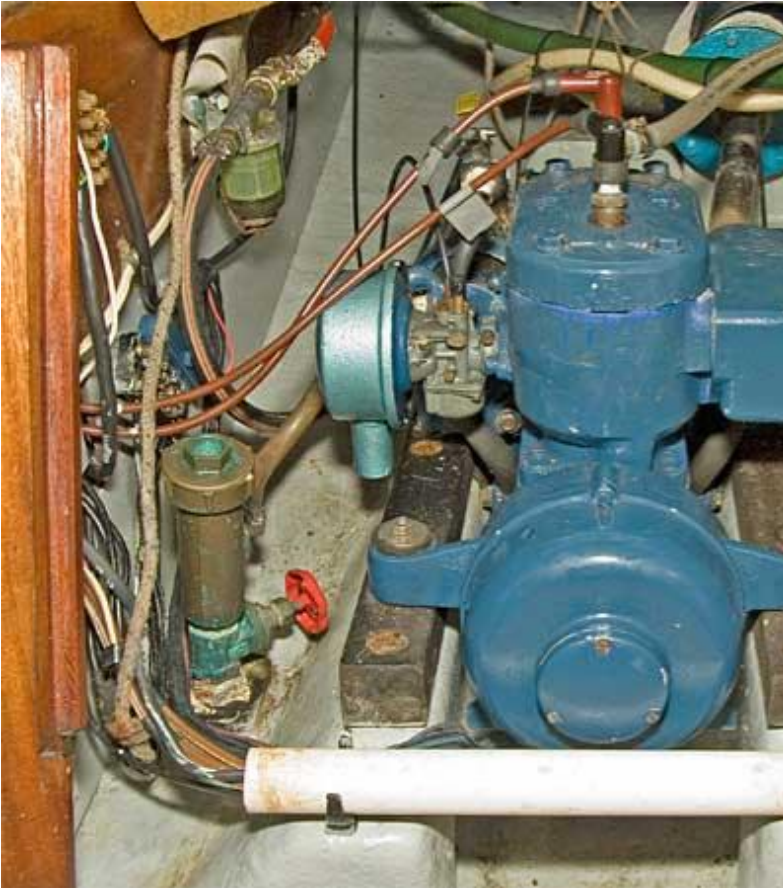
1240	Horse Power	720 hp each
1245	Engine Hours	750 hours based on the engine hour meter.
1255	Hoses and clamps	Maintenance Recommended. Water intake hoses have cracked covers. Recommend replacing both engine cooling intake hoses.
1260	Belts and pulleys	Functional. No cracks or splits sighted. Pulleys/belts appear to be in line.
1265	Engine mounts	Functional. Engine mounts appear to be well secured to the support stringers.

Maintenance Recommended. Water intake hoses have cracked covers. Recommend replacing both engine cooling intake hoses.

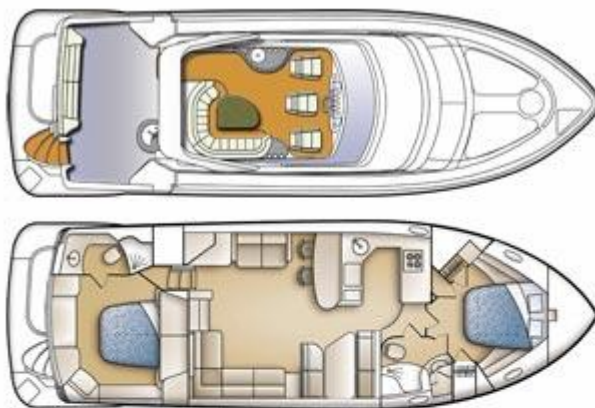
2110	Windshield	Maintenance Recommended. V type windshield. Canvas appears to be separating from windshield. Recommend repairing.
2120	Hatches	Functional. Total of 3 hatches: One (1) forward above the master stateroom, One (1) over the port stateroom, and one (1) over the galley. Engine compartment and Accessory Room each have a separate access hatch.
2130	Canvas	Functional. See note under Windshield item.
2145	Bowsprit / Forestays	Functional.
2155	Rails	Functional. Welded stainless steel rail system, runs from the bow aft on both port and starboard sides to where the radar arch intersects at the cockpit. Diameter of rail system is 1 1/8".

Maintenance Recommended. V type windshield. Canvas appears to be separating from windshield. Recommend repairing.
