Building Inspection Report

Inspected By: William P. Williams RHI

Home Inspected: 1212 North Maryland
Superior, WI 54880

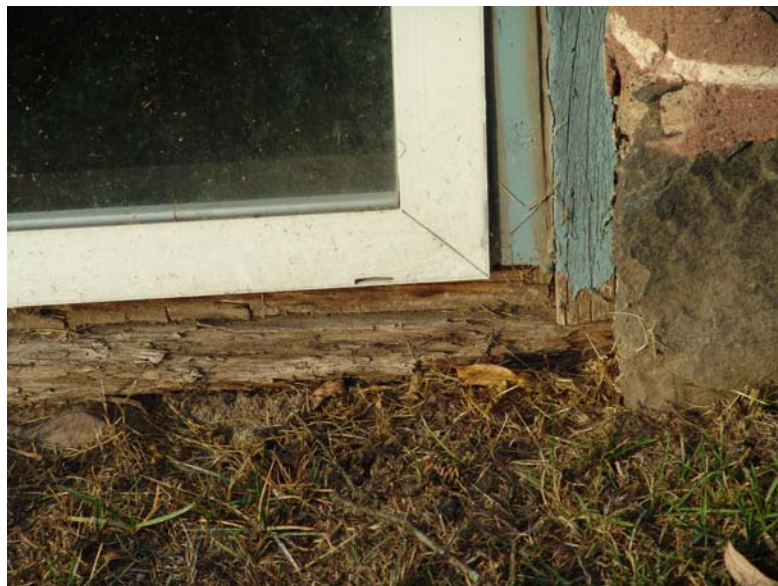
Step #	Component	Comments
10	Basement windows	Lacks Maintenance. Wood. The paint on the basement windows is showing sings of peeling and/or decay. Recommendations: Try scrapping the old finish off and apply exterior primer paint. If the wood is decayed beyond painting - replace the complete window.

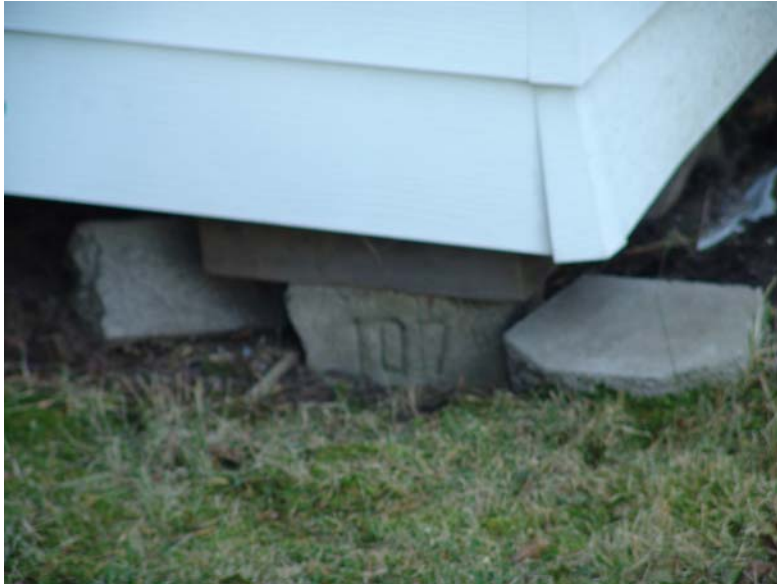
43 Steps

Lacks Maintenance. Wood. The steps have settled away from the house.

Recommendation: Properly reattach the step unit to the house and apply the fill under the bottom of the steps to prevent further settling. The stringers will continue to decay while setting in moisture. Place the stair stringers on patio blocks to keep them out of the wet earth.

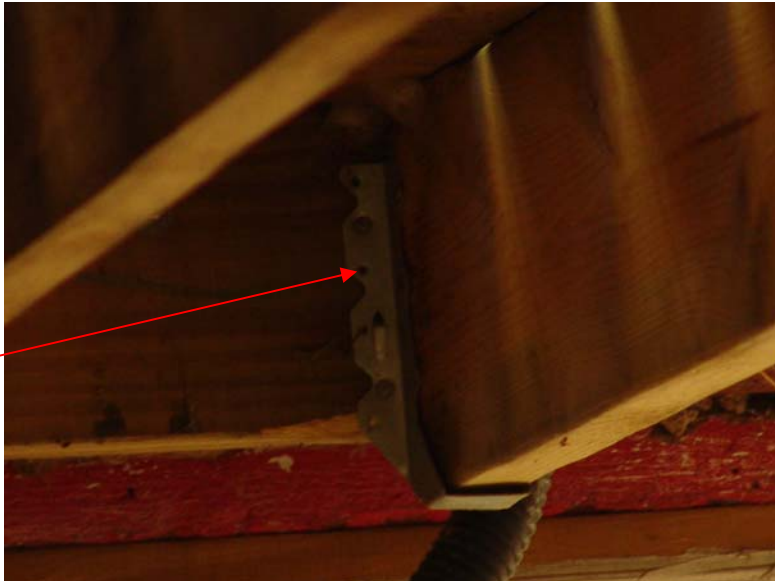
45 Deck

Lacks Maintenance. Rear; Open; Wooden. Some of the fastener in the engineered hangers are missing or are filled with improper fasteners.

Recommendation: When engineered hangers are installed at stringers or joist for support, all of the holes in the hanger must be filled with the proper fastener. Sheet rock screws, deck screws and roofing nail are not acceptable. Engineered joist hangers nail needs to be used. Fill all of the nail holes in the hangers.

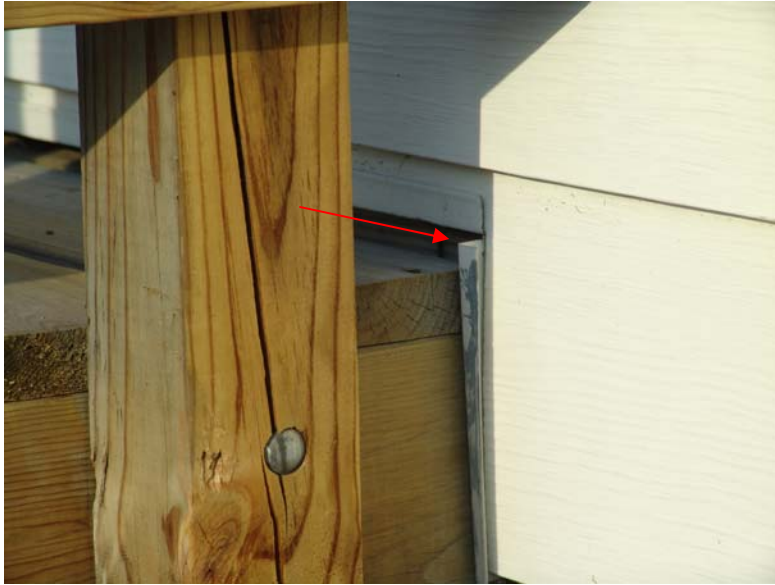
The flashing between the house and the decking is not installed correctly, damaged or not installed at all. Water could be seeping behind the flashing and decaying the house structure.

Recommendation: Remove sufficient decking boards and the cladding on the house to allow room for working. Install a preformed metal flashing behind the cladding (siding) out and over the top of the ledger board to allow for water to shed over the front of the ledger and not behind the ledger.

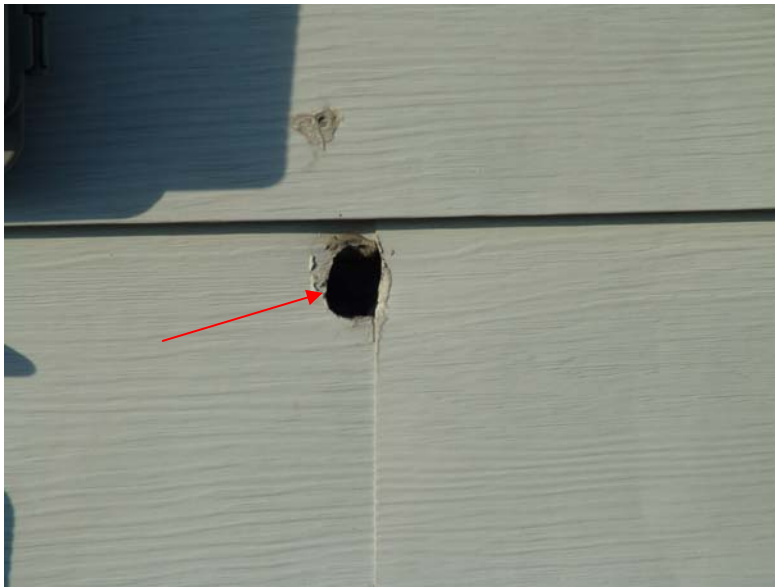
Step #	Component	Comments
50	Exterior Finish	Lacks Maintenance. Metal. There are opening in the siding that needs to be repaired.

Recommendation: Caulk all of the opening in the siding including around all window and doors that appear dry or deteriorated caulking. These opening allow water to enter behind the siding and decaying the underlayment. Use a good grade of caulk. This is not the time to shop for inexpensive caulking. If silicone is used be sure that the silicone is pintable and useable in low temperatures.

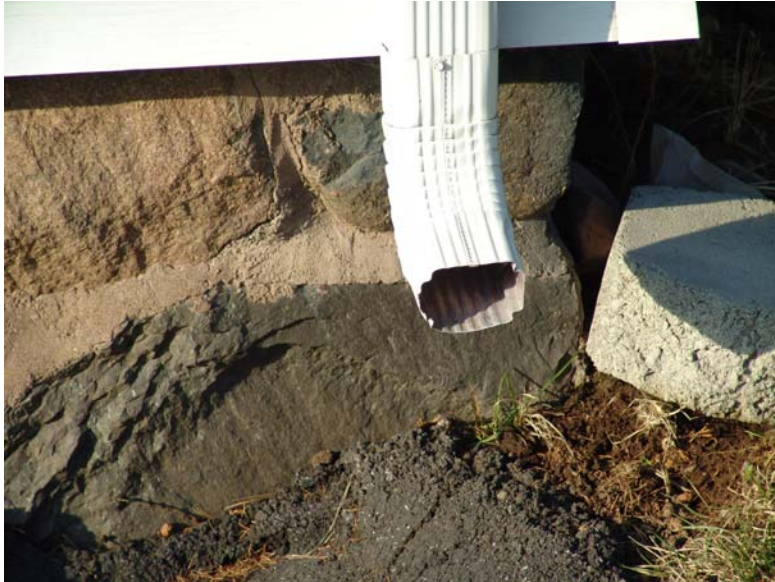
53 Downspouts Lacks Maintenance. Metal. Down spouts should have an 8 foot extension added to direct the water away from the foundation.

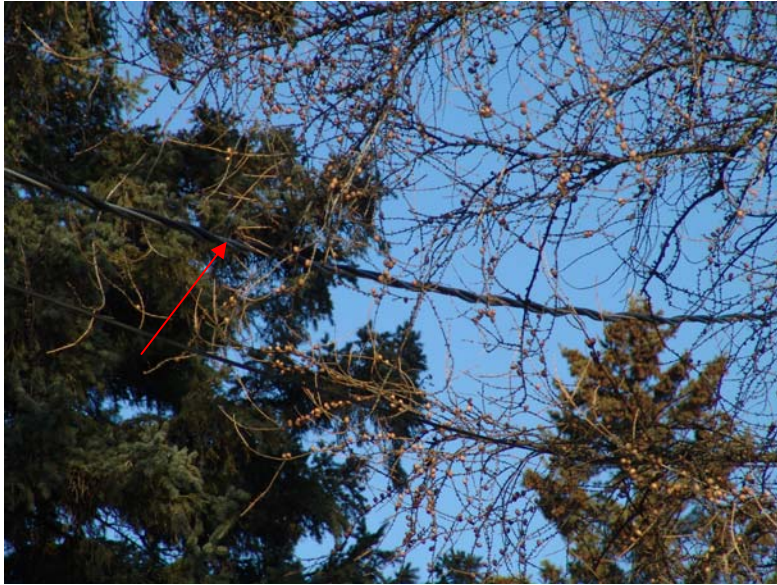
Step #	Component	Comments
140	Exterior Service	<p>Lacks Maintenance. Overhead. The service wires are touching or close to touching the trees.</p> <p>Recommendation: Contact the electrical company and they will trim the branches to clear the wires.</p>

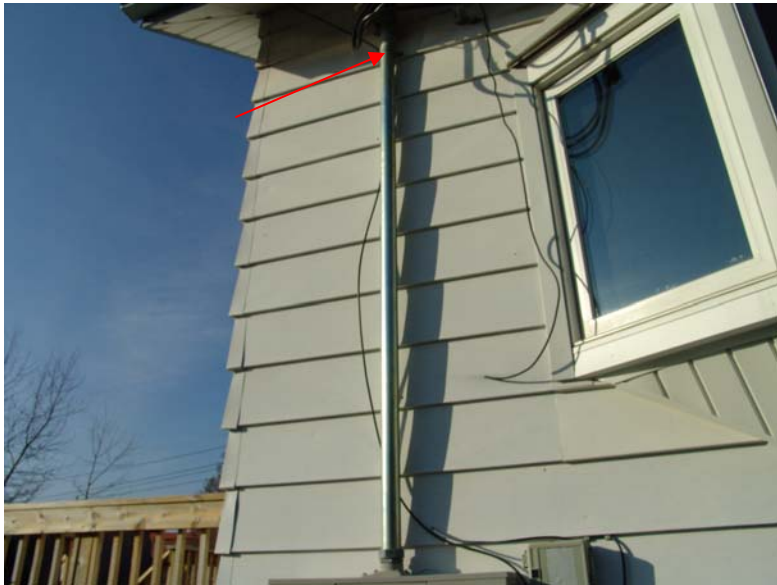
141 Service
Entrance Cable

Serviceable. In conduit. The masthead is not properly secured to the building.

Recommendation: Install a clamp (with bolts - not screws or nails) within 12 inches of the masthead. There should be clamps 12 inches from the meter socket and every 4' thereafter.

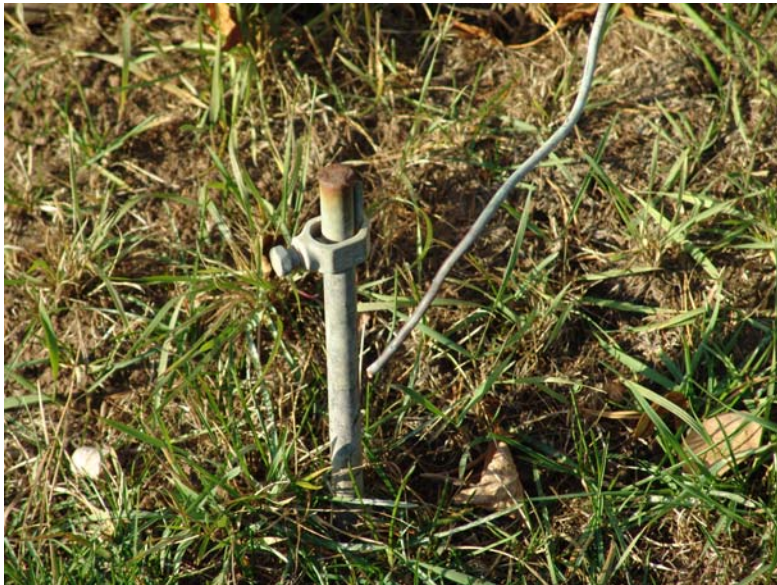
142 Grounding Not Safe Condition. Ground stake. The ground wire that is connected to the ground rod should be below the surface of the earth for proper grounding.

Improper/loose connection noted on the electrical ground.

Recommendation: This rod should be covered with earth. It is important that the grounding rod for the electrical system be 96 inches below the earth.

Recommendation: The grounding wire should be continues from the electrical panel in the building to the grounding rod. It should be attached with the proper connecter suitable for burial into the earth. In some cases two grounding are required. This is most likely to be on newer electrical installations.

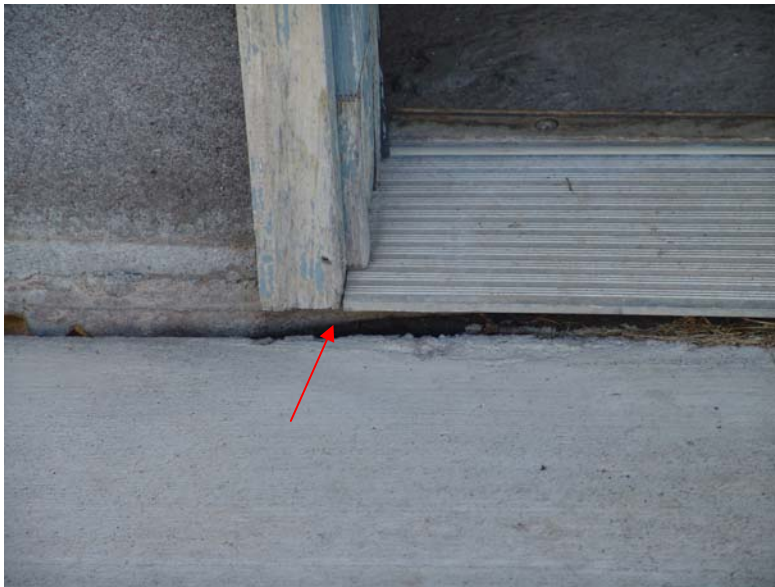
- 121a Exterior Walls Serviceable. Wood siding.
- 121b Passage door to exterior Lacks Maintenance. Steel. The support under the door threshold of the front door is missing or damaged.

Recommendation: A support should be installed under the threshold of the passage door to keep the threshold from bending and breaking the seal of the jamb sides allowing water to enter this area and decaying the door assembly.

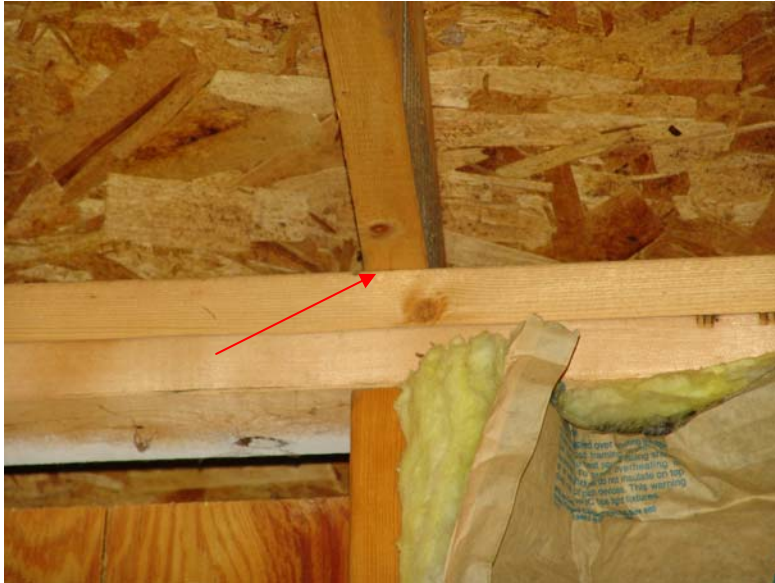
- 121c Garage Driveway Serviceable. Asphalt; Cement.
- 121d Exterior electrical Serviceable.
- 122 Roof Structure Lacks Maintenance. Trusses; Open ceiling; OSB Sheathing. There are not ties from the rafter or trusses to the top sill place.

Recommendation: There should be metal ties installed between the trusses and the wall system. These metal ties help prevent uplift of the roofing system in the event of strong winds. These metal straps are easy to install and it is recommended that this be performed.

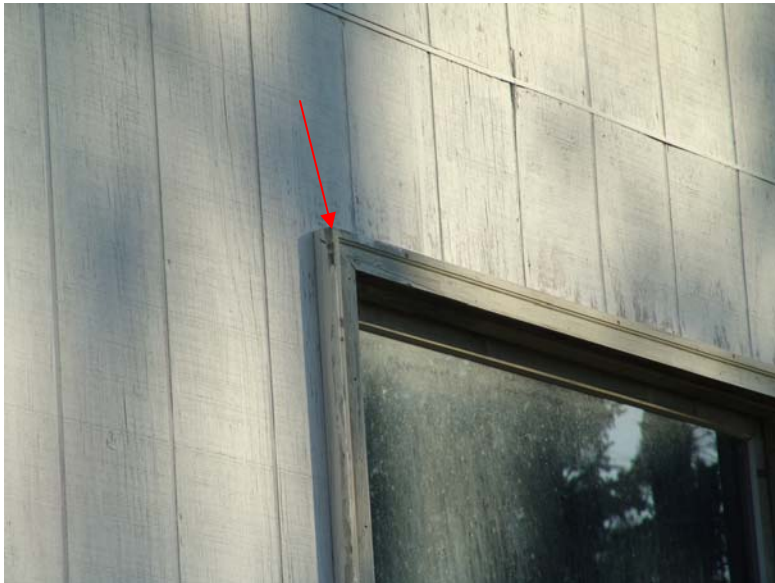
123 Window

Lacks Maintenance. The metal drip edge is not installed over some/all of the windows.

Recommendation: This metal drip edge prevents the water from entering behind the top of the windows or doors and damaging or decaying the building sheathing. Keeping this area caulked will help prevent water penetration

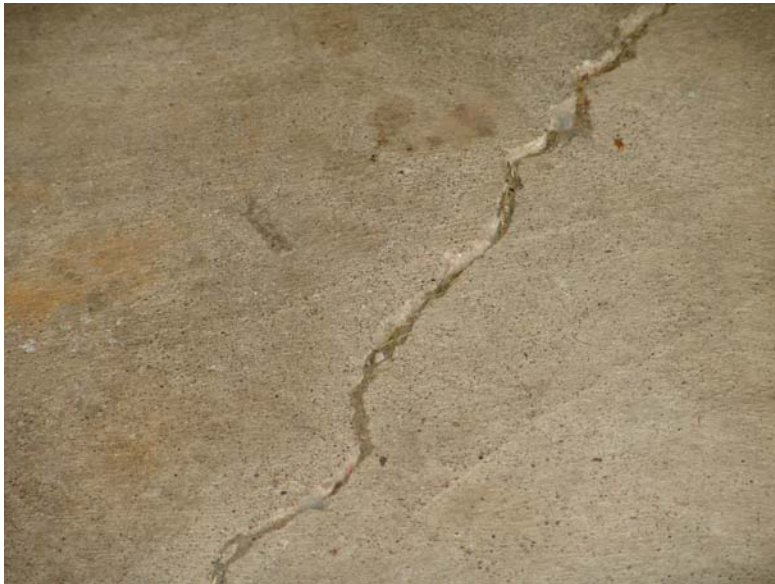
| 126 | Floor | <p>Serviceable. Concrete. Cracks up to 1 inch found in the garage floor.</p> <p>Recommendation: These cracks can be cleaned and hydraulic cement forced into the cracks to keep future water and debris out of the cracking.</p> <p>The garage floor has cracked and settled through the years. Usually when the crack is in the center of the floor and parallel with the ridge line the footings were not sufficient in size for the snow load on the exterior walls.</p> <p>Recommendation: If the settlement is beyond repairs the garage can be jacked up and a new foundation and slab be poured in place.</p> |

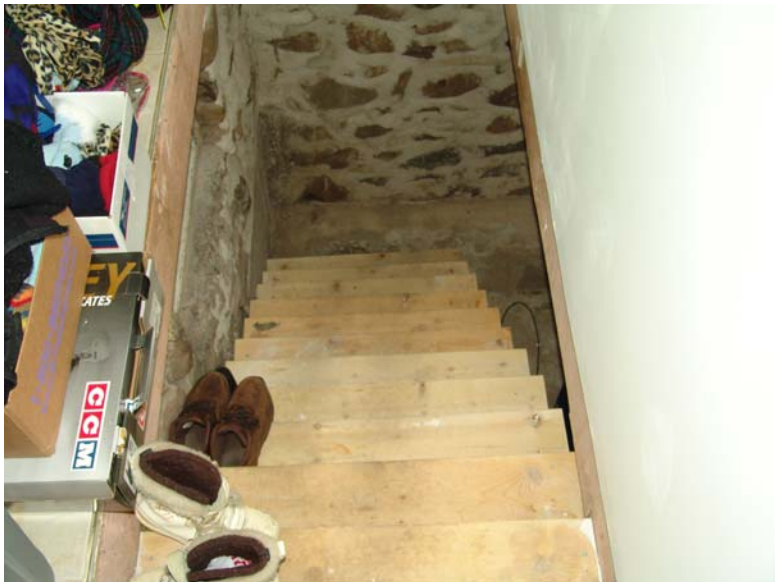
Step #	Component	Comments
01	Description	Full basement.
02	Stairs	Not Safe Condition. Wood. When four or more steps are present there should be a hand railing installed for safety. If the steps are more than 44 inches wide there should be two handrails installed.

Recommendations: Install a hand railing. Contact your governing agency as to the specifications needed to provide a safe hand rail.

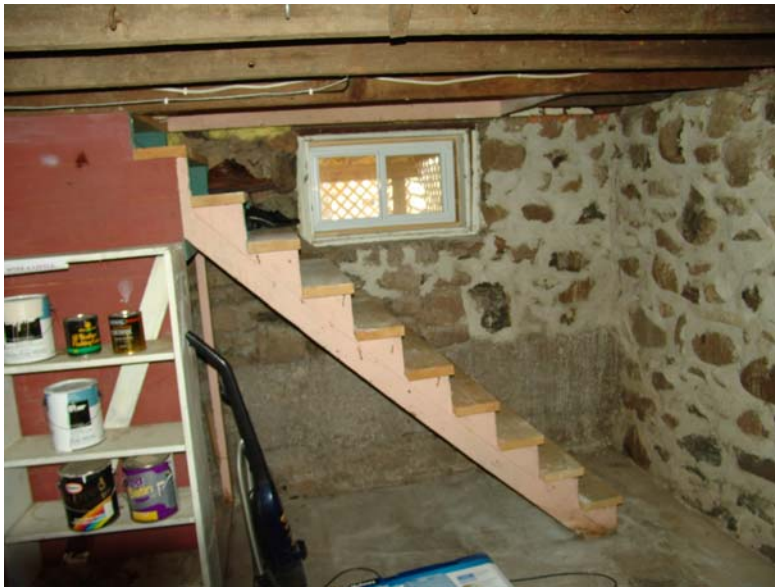
Low headroom is evident at the basement stairs. Injury may result from accidental impact. A minimum height of six feet eight inches is typical in modern construction. This less than desirable condition is usually tolerated in older construction.

Open stair walls. One or both of the sides of the stairs is open or the openings are large enough for a child or person to fall off of the steps.

Recommended correction - Install material on the open side of the stairs with opening four inches or less so a small child can not fall through the openings.

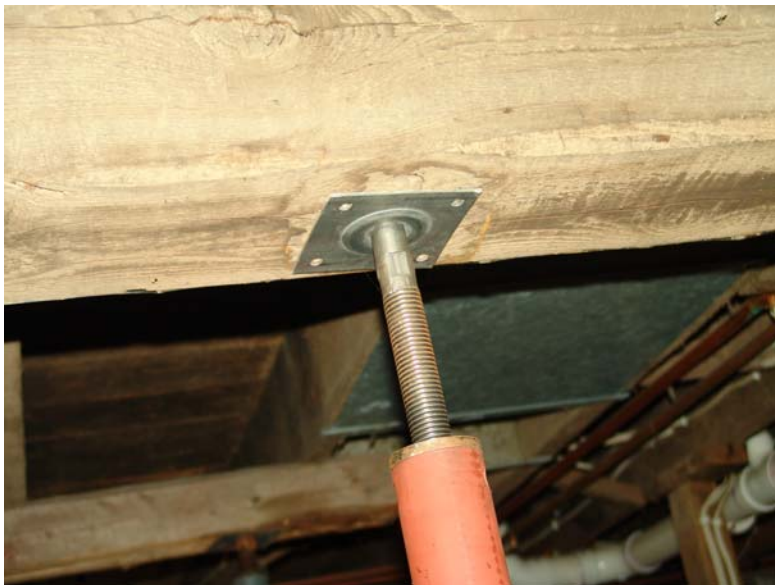
07 Bearing Structure Lacks Maintenance. Steel posts. When steel posts are used for support they must be bolted to the supported member and to the basement floor.

Recommendation: The steel post or posts used for structural support need to have bolts installed to fastening the steel post to the supported beam and also the steel post must be bolted to the cement floor or be encased in the cement floor.

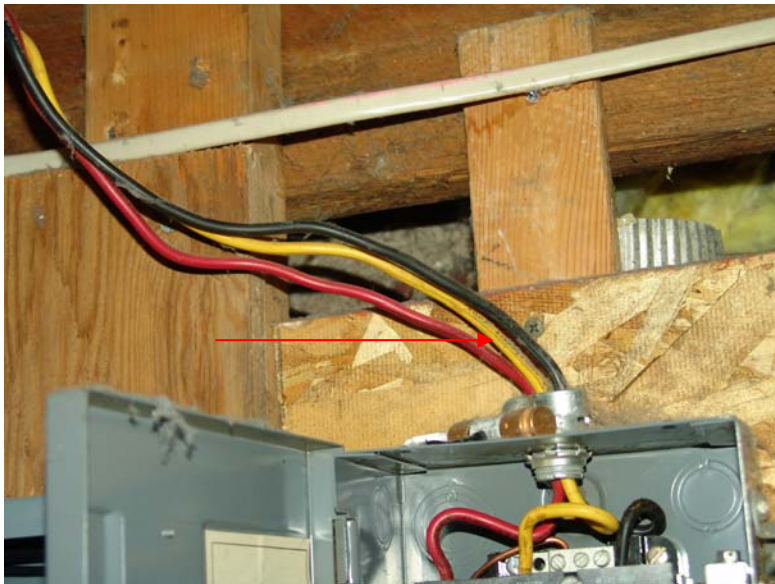
The wire servicing the washer/dryer is not protected or in conduit.

Recommendation: This wire is a 240 volt line and is dangerous if not protected. The wire should be installed in a protective conduit.

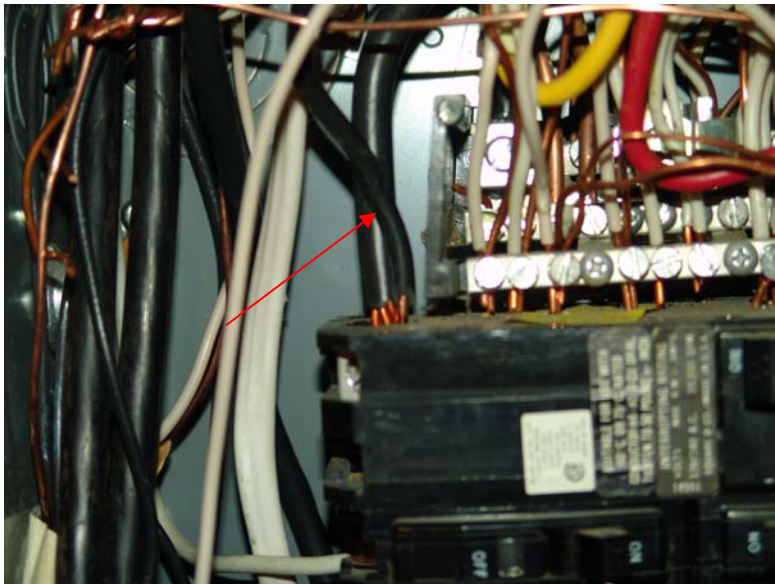
The poor condition of the electrical wiring in this building is serious enough to call for a licensed electrician for repairs.

Recommendation: A breaker/fuse does not protect the circuit. The tapped wire should be moved in the panel so it will be connected to a breaker or fuse after the main disconnect.

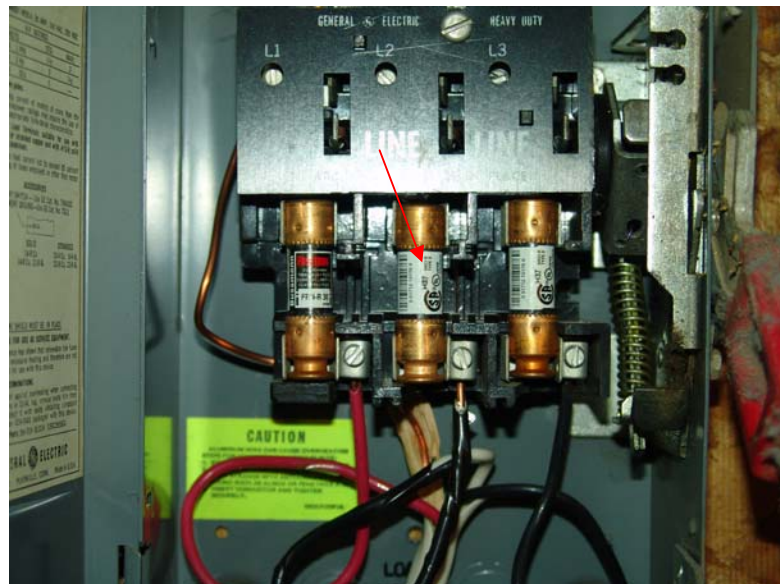
147	Wiring Conductors	Serviceable. Copper.
148	Miscellaneous Defects	Not Safe Condition. Fused neutral.

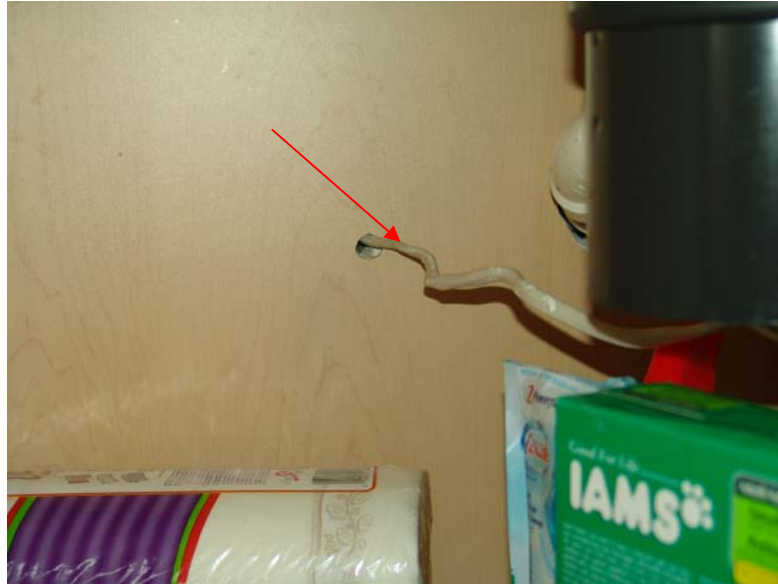
Step #	Component	Comments
90	Sink/Faucet	Serviceable.
90a	Counter Top(s)	Serviceable.
91	Disposal	Not Safe Condition. Recommend adding conduit on the electric wires in the sink cabinet for safety.
