Borealis Home Inspection Service

Doc #: 124A Inspector: Dave Mashek

Date: 7/23/2004

Dwelling Address: 2424 Oak Ave.
Northbrook, IL 60062

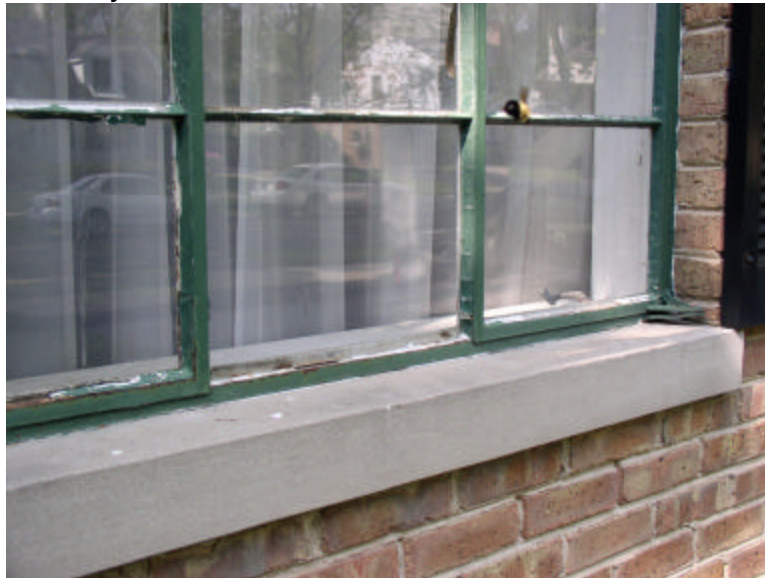
Step #	Component	Comments
1101	Driveway	Functional. Asphalt.
1102	Walkways	Functional. Concrete.
1103	Exterior Wall Cladding	Functional. Brick. Siding on this home is covered with metal/vinyl. The inspector is unable to view the condition of covered areas. It is important to keep siding well caulked and sealed to prevent moisture penetration.
1104	Trim	Functional. Trim on this home is covered with aluminum. The inspector is unable to view the condition of covered areas. It is important to keep trim well caulked and sealed to prevent moisture penetration.
1105	Window & Frames	Review. Casement; Metal frame; Vinyl frame. Caulking should be applied around all windows, doors, and any voids where necessary. Loose glazing observed at 1st floor right, suggest re-glazing as necessary.

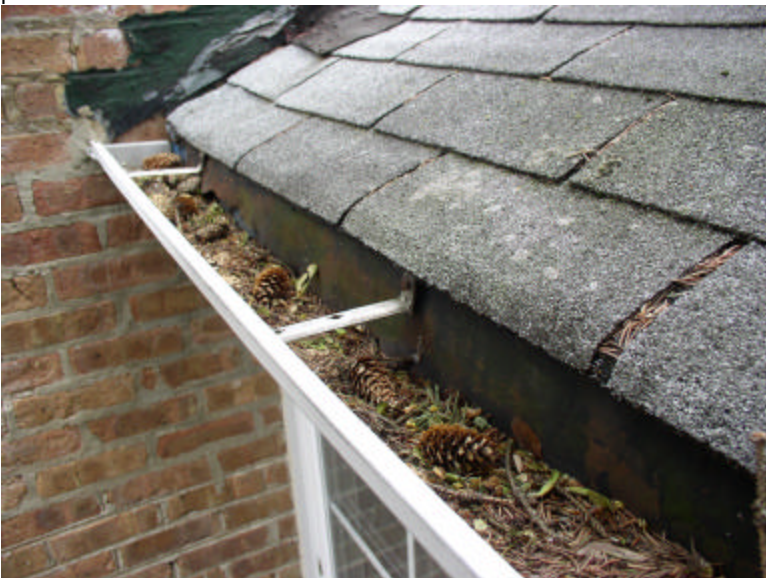
1107	Gutters / Downspouts	Maintenance. Aluminum. Debris blocked downspouts observed at rear, suggest cleaning gutters and downspouts, which should be a regular part of maintenance.

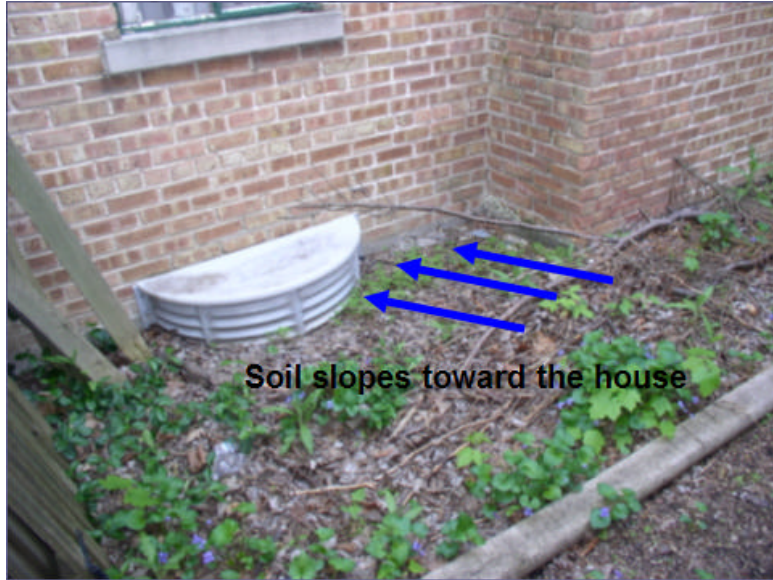
- 1115 Lot / Grade Drainage Maintenance. Minor slope. Grade appears to slope toward the foundation at back. Reshaping the area around the foundation to move water away from the structure would help to minimize movement of the foundation system which can be caused by poor drainage.

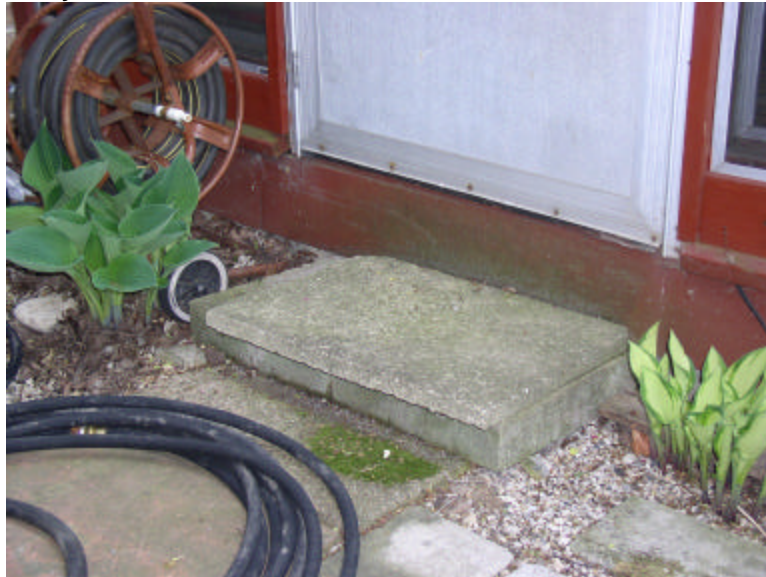
Review. Wood. Uneven step rise. Corrections are needed to ensure safety.

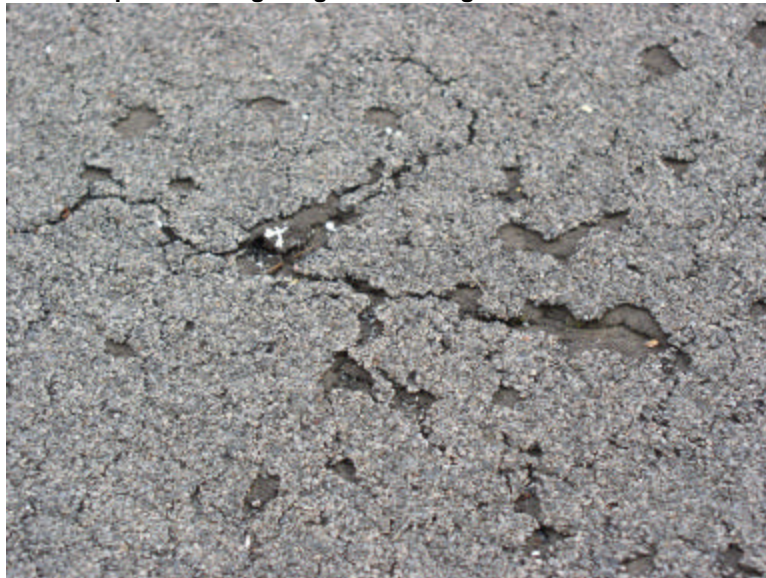
Roof has poor selvedge edge roll roofing surface.

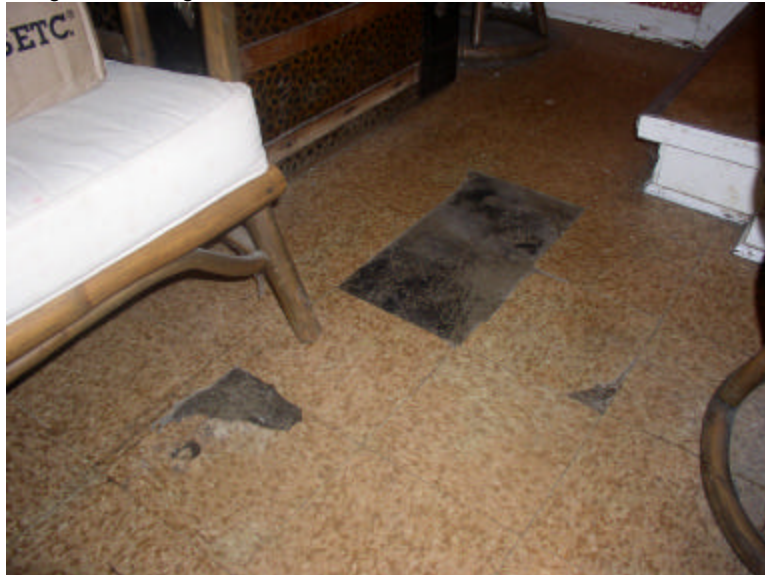
Step #	Component	Comments
1601	Access	The basement was accessed from the hall. Limited access due to personal belongings, client is advised to confirm condition with sellers prior to close.
1602	Stairs	Functional. Wood.
1603	Floor	Marginal. Missing tiles.

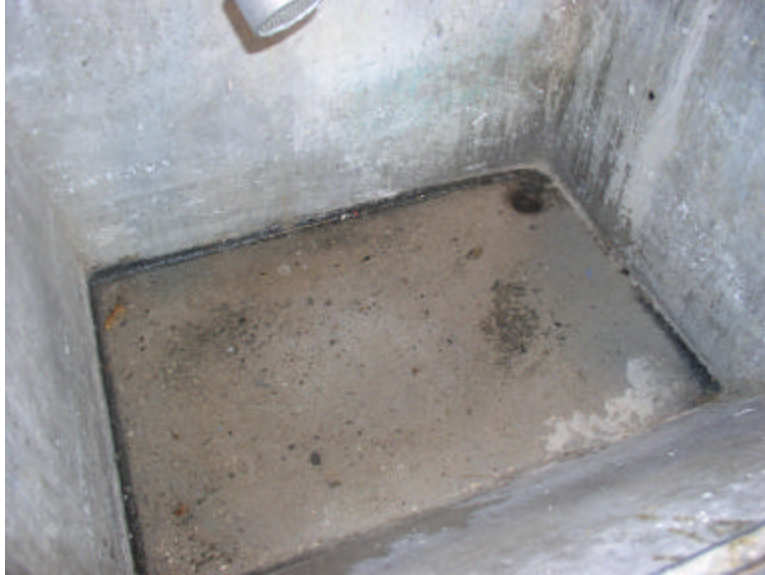
1614	Electrical	Functional.
1615	Ventilation	Functional.
1616	Insulation	Functional.
1617	Laundry Tub / Sink	Marginal. Inadequate drainage causing backup of discharge from dishwasher and kitchen sink.

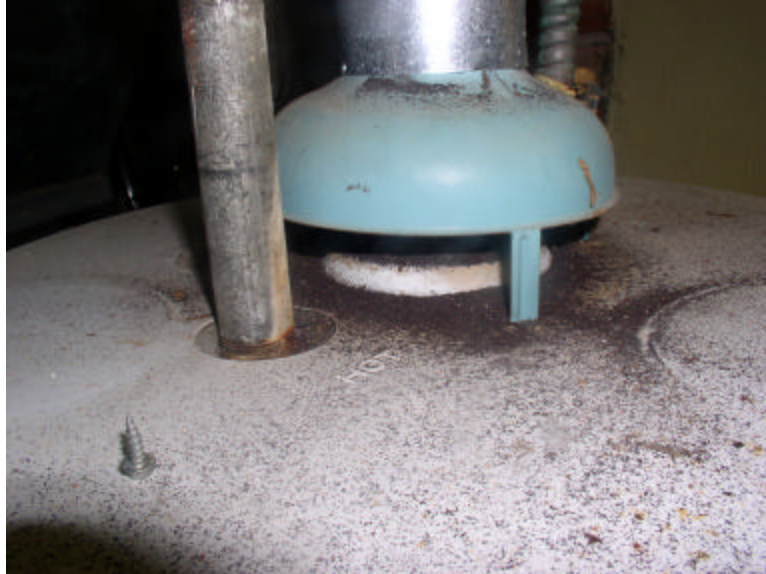
2108	Flue Venting	Functional. Metal. Rusted draft hood noted, this is a sign of improper venting. This is a safety concern, which should be evaluated by a qualified contractor. No backdrafting was occurring at the time of inspection. Advise obtaining maintenance and repair history. If no past repair can be confirmed, we suggest having a safety evaluation. See comments in the chimney section.
------	--------------	--

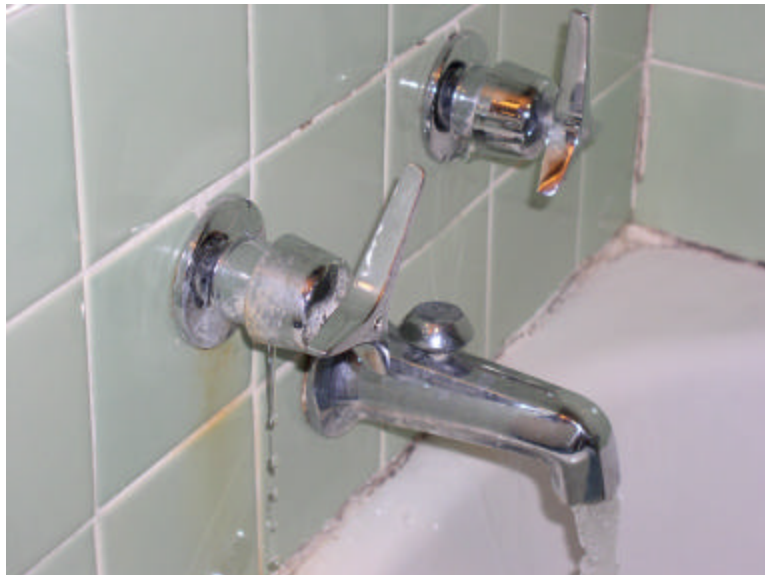
Step #	Component	Comments
2401	Floor	Functional. Carpet.
2402	Walls	Functional. Drywall.
2403	Ceiling	Functional. Drywall.
2404	Doors	Functional. Hollow core.
2406	Windows	Functional. Casement.
2407	Heat / Cooling Source	Functional. Central heating/cooling.
2408	Electrical	Functional. Ground fault interrupter provided for safety.
2409	Exhaust Fan	Functional.
2410	Sinks	Functional. Fiberglass.
2411	Sink Faucets	Functional.
2412	Traps / Drains / Supply	Functional.
2413	Toilet	Functional.
2417a	Tub	Review. Leaking noted around tub-shower faucets valves. New washers should be installed.

- 2417a. Tub **Review. Leaking noted around tub-shower faucets valves. New washers should be installed.**

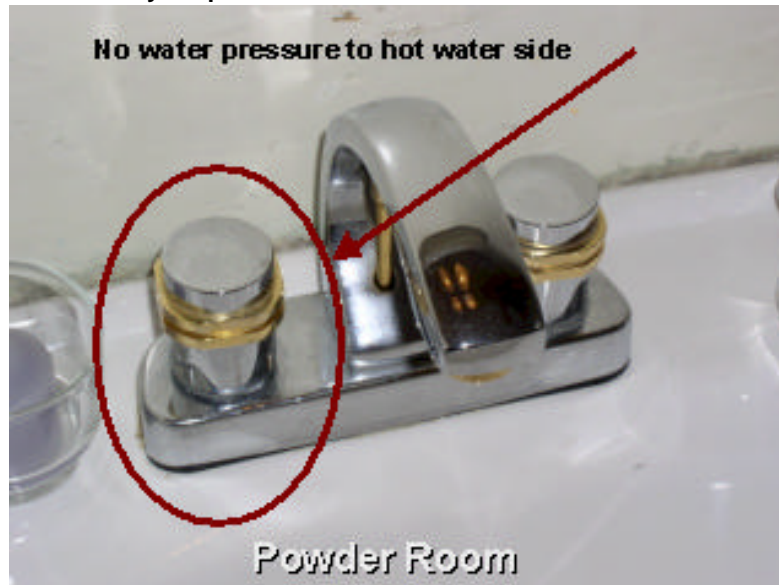
Step #	Component	Comments
2401.2	Floor	Functional. Carpet.
2402.2	Walls	Functional. Drywall.
2403.2	Ceiling	Functional. Drywall.
2404.2	Doors	Functional. Hollow core.
2407.2	Heat / Cooling Source	Functional. Central heating/cooling.
2408.2	Electrical	Functional. Ground Fault Circuit Interrupters (GFCI) may not have been required when the home was built. Suggest client consider upgrading with GFCI's at all receptacles near water sources, such as the kitchen, the bathrooms, the garage, and exterior receptacles to enhance safety. Upgrades should be performed by a licensed electrician.
2409.2	Exhaust Fan	Functional.
2410.2	Sinks	Functional. Fiberglass.
2411.2	Sink Faucets	Marginal. Lower/reduced hot water flow observed. Recommend review by licensed/qualified professional for repair or replacement as necessary. ***picture
