Knights Home Inspection

PROPERTY INSPECTION REPORT	File #:024
Prepared For:	Test Client – for v7-3	
	(Name of Client)	
Concerning:	555 Holly Trail East Holly Lake Ranch, Texas 75765	
	(Address or Other Identification of Inspected Property)	
By:	Mr. Inspector #5555	1/11/2014
	(Name and License Number of Inspector)	(Date)
	(Name License Number of Sponsoring Inspector)

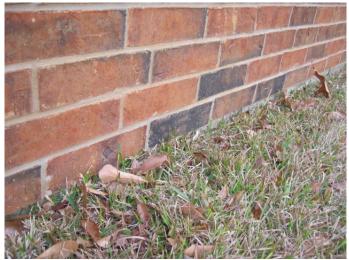
Grade/Slope -

Under today's building standards there should be a minimum of (4) inches of foundation visible below the brick or wood veneer. High soil at various areas around the foundation.

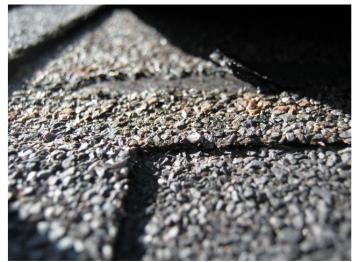
The shingles on the roof have granules missing at various locations. The Granules protect the matting from the sun's UV rays, with the granules missing from the roof matting the roof will ware uneven. Recommend a roofer for further evaluation as to the longevity of the shingles on the roof due to the missing granules.

Recommend further evaluation and repair by a roofing specialist due to the areas that is missing granules on the rear slope and the front slope shingles. roofer for best option of repair.

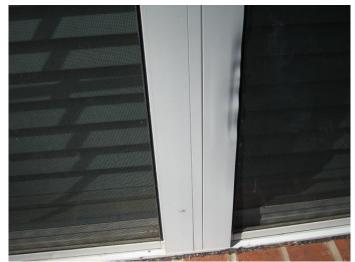
Window at the left side has a damaged frame (this is cosmetic only)

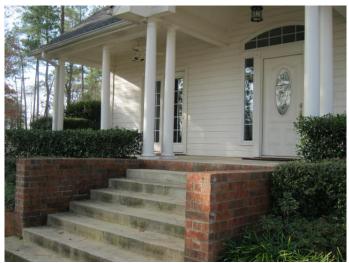
Side; front rear of home has No rails. In the inspector's opinion, the surface rise is high enough to warrant safety rails. Recommend rails be installed properly.

Step with more than three risers should have a handrail. Railings should also be provided for open sides of porches or decks above 30"; recommend adding rail at the front and the right side and the area at the back yard stairs as safety feature.

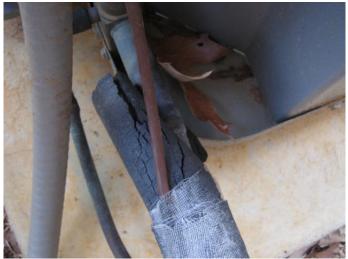
Sections of the insulation on the compressor lines appear to be missing. These lines should be suitably insulated for the proper operation of the compressor. The insulation on the lines at this time is brittle.

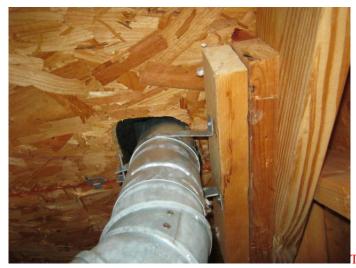
The water heater flue pipes

have contact with combustibles (The roof sheathing). This should be repaired; TREC standards state this is a fire hazard.
