Knight's Marine Surveyor Inc.

Survey #: 123455 Surveyor: Jeff Knight
Survey Date: 10/23/2007
Vessel Surveyed at: 220 Sun Lane
San Diego, CA 34451
Client's Name: Jim Buyer
300 Tuna Dr.
San Diego, CA 34451
Survey For: Purchaser Survey Purpose: Assess Overall Condition

100	Vessel Type	Motor yacht.
101	Year Built	1990
102	Make / Model	Grand Harbour 57' Express Cruiser
103	Vessel Name	My Glory
104	Hull ID	HAT876768
105	State License #	CA4566
106	Home Port	San Diego
107	Tonnage	25 GRT
108	Est. Top Speed	10 knots
109	Fair Market Value	\$315,000

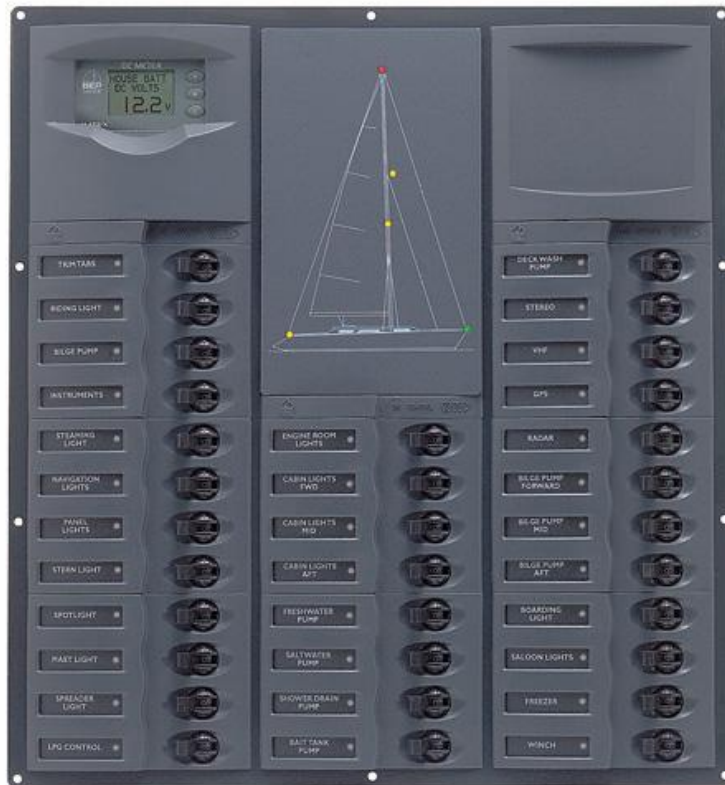
Step #	Component	Comments
1350	Voltage System	Functional.
1355	Selector Switch	Functional.
1360	Main Breaker(s)	Functional.

1365	Wiring	Functional. Insulated copper strand to ABYC.
1370	Polarity Check	Functional.
1375	Shore Receptacles	Functional.

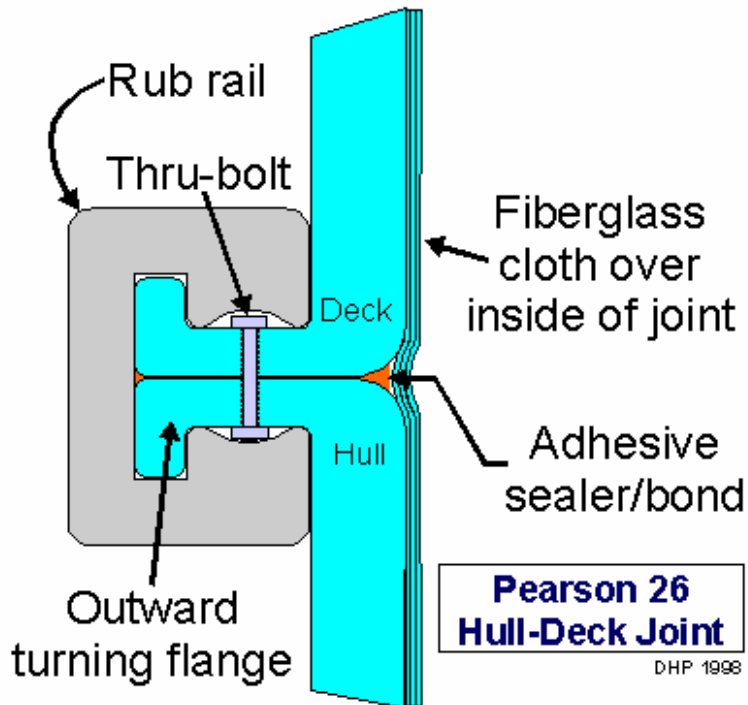
- 1540 Stem Not Inspected.
- 1550 Hull to Deck Joint Functional. Molded Fiberglass Reinforced Plastic cored with plywood. No leaks evident.

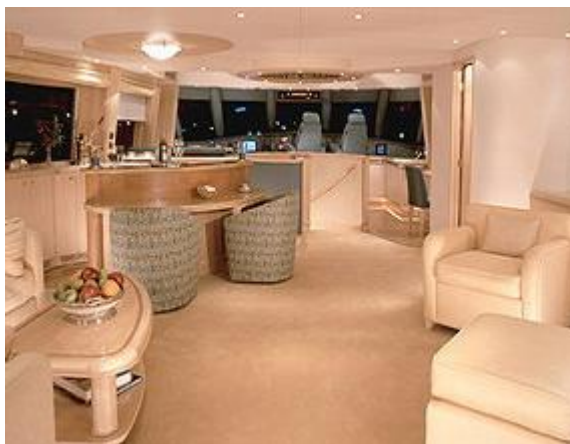
- 1560 Storage area Functional.
- 1570 Wet bar Functional. Full wet bar with sink.

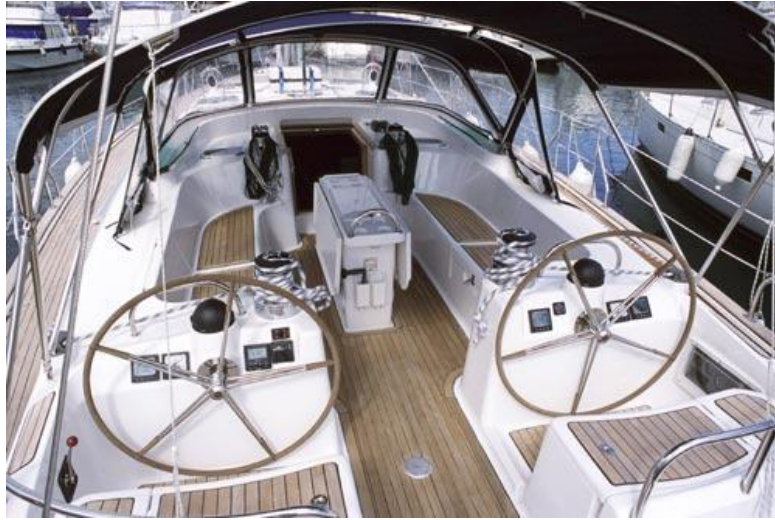
2165 Flybridge Functional.

2170 Upper deck Functional. White gel coat with molded in non-skid. Condition is serviceable.
