Building Inspection Report

Inspected By: William P. Williams RHI

Home Inspected: 1212 North Maryland
Superior, WI 54880

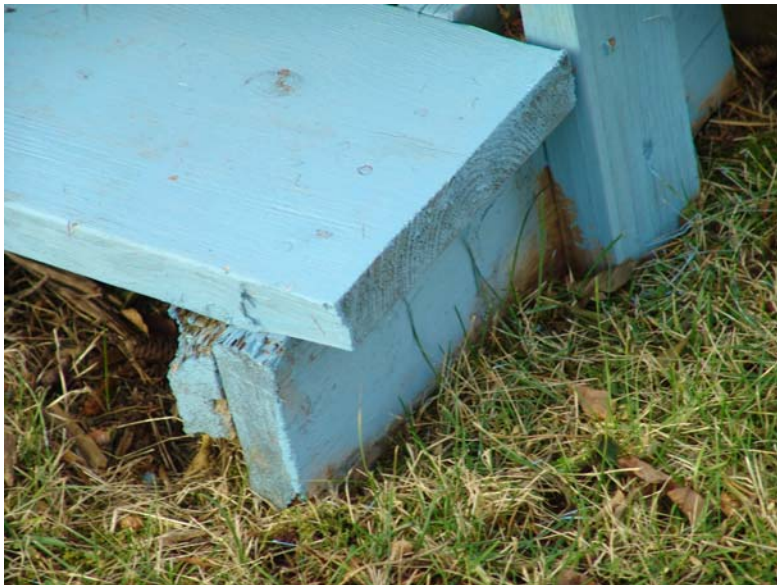
Lacks Maintenance. Wood. The steps have settled away from the house.

Recommendation: Properly reattach the step unit to the house and apply the fill under the bottom of the steps to prevent further settling. The stringers will continue to decay while setting in moisture. Place the stair stringers on patio blocks to keep them out of the wet earth.
